**Project**

**Project Name:** 29042024 FOUR VILLAGES CAR PARK CT3 1ST  
**Project Description:** CCTV SURVEY  
**Project Number:** MTS TICKET NO.208971  
**Project Status:** On Site  
**Project Date:** 29/04/2024  
**Inspection Standard:** MSCC5 Sewers & Drainage GB (SRM5 Scoring)

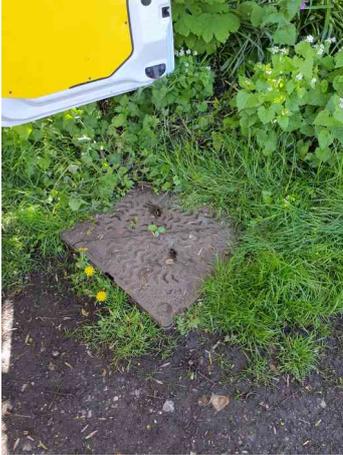
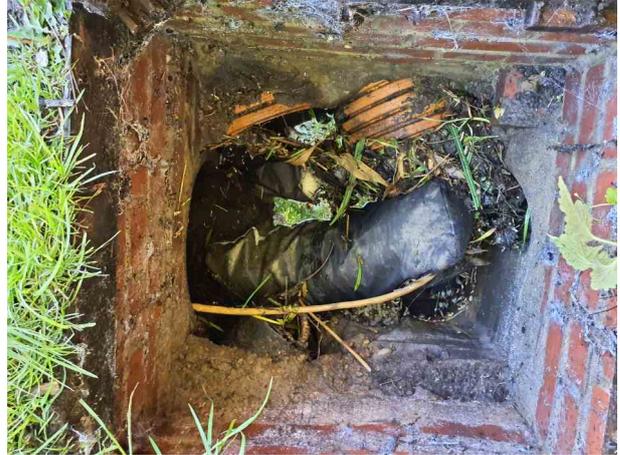
OUT FALL 2\_Upstream\_240429\_081250\_\_4.jpg, 00:00:00,  
 0.00 m  
 Start node, manhole, reference: SWMH 4

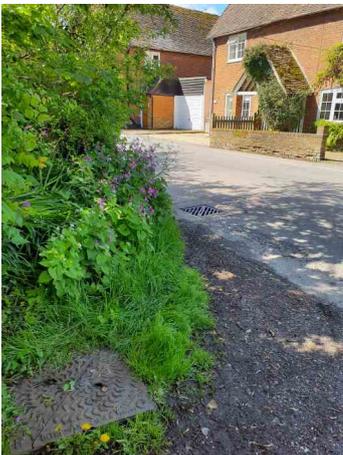
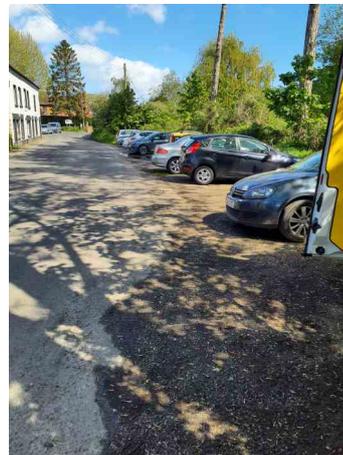
OUT FALL 2\_Upstream\_240429\_081250\_\_2.jpg, 00:00:00,  
 0.00 m  
 General remark, ABOVE GROUND VIEW

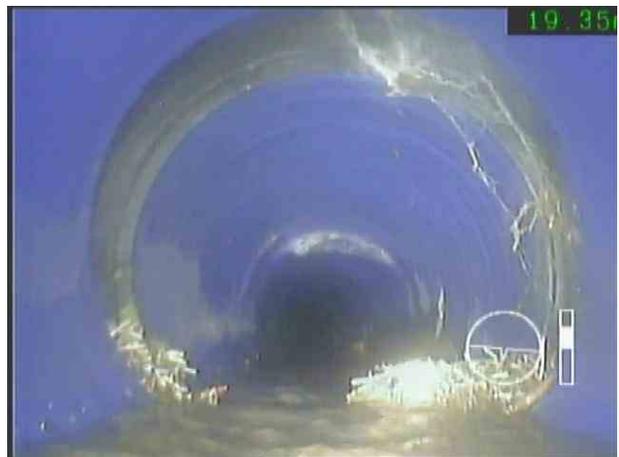
WE THEN SURVEYED FROM SWMH7 D/S TO SWMH 6 AND FOUND 10-15% ROOTMASS LAYING IN THE BOTTOM OF THE PIPE AND CAMERA IS UNABLE TO PASS ROOTS.

Scale:	1:191	Position [m]	Code	Observation	MPEG	Photo	Grade
Depth: 1.20 m SWMH6							
	0.00	MH	Start node, manhole, reference: SWMH6	00:00:00	SWMH 7_Upstrea m_240429		
	0.00	WL	Water level, 0% of the vertical dimension	00:00:00			
	0.30	REM	General remark: ABOVE GROUND VIEW	00:00:00	SWMH 7_Upstrea m_240429		
	13.40	RM	Roots, mass, 10% cross-sectional area loss	00:01:48			3
	19.35	RM	Roots, mass, 15% cross-sectional area loss	00:02:30	SWMH 7_Upstrea m_240429		3
	21.63	DES	Settled deposits, fine, 20% cross-sectional area loss	00:03:06			4
	22.00	SA	Survey abandoned: UNABLE TO PASS	00:03:30

SWMH 7\_Upstream\_240429\_123324\_\_13.jpg, 00:02:30, 19.35 m  
 Roots, mass, 15% cross-sectional area loss
