Fire Risk Assessment Review

Flat 1-70, Windsor House, Belmont Road [UPRN:CCCBLK310130A] (Independent Living)

Type 3 Fire Risk Assessment

DDS Job Number: 72614

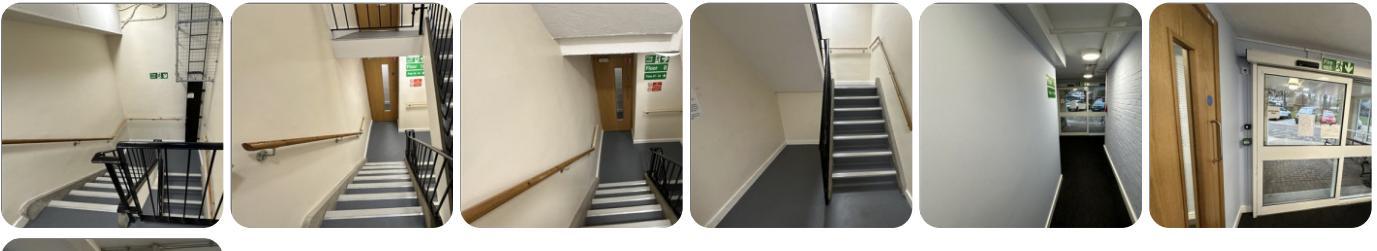
QUESTION 24 PHOTOS

At the time of the inspection the escape routes were free of obstructions, slip and trip hazards.

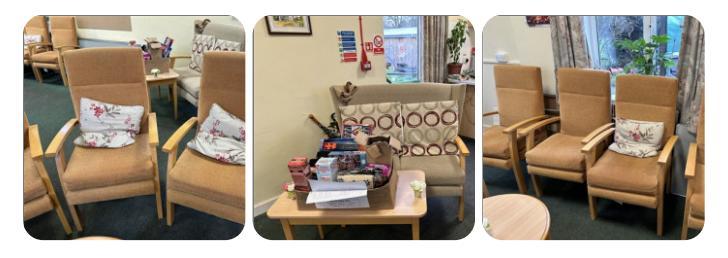
QUESTION 32 PHOTOS

No issues found at the time of the inspection, despite no fire retardant labelling identified the furniture all appeared to be in good condition.

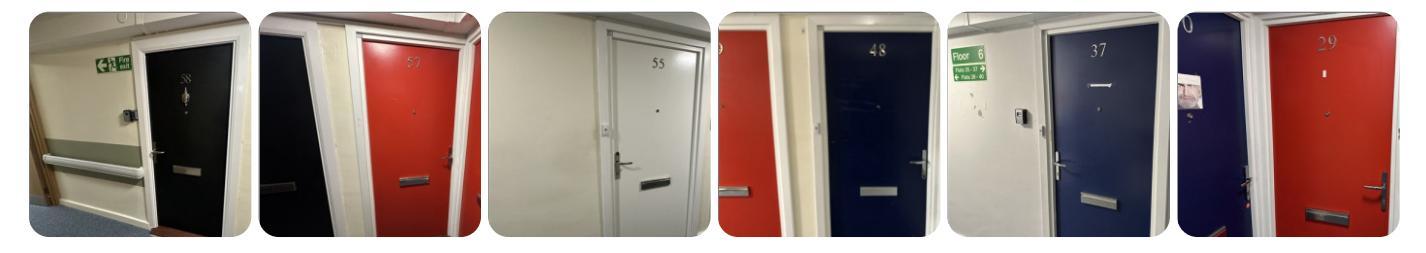
QUESTION 63 PHOTOS

All front doors sampled appeared to be of a fire rated construction with no visible damage.

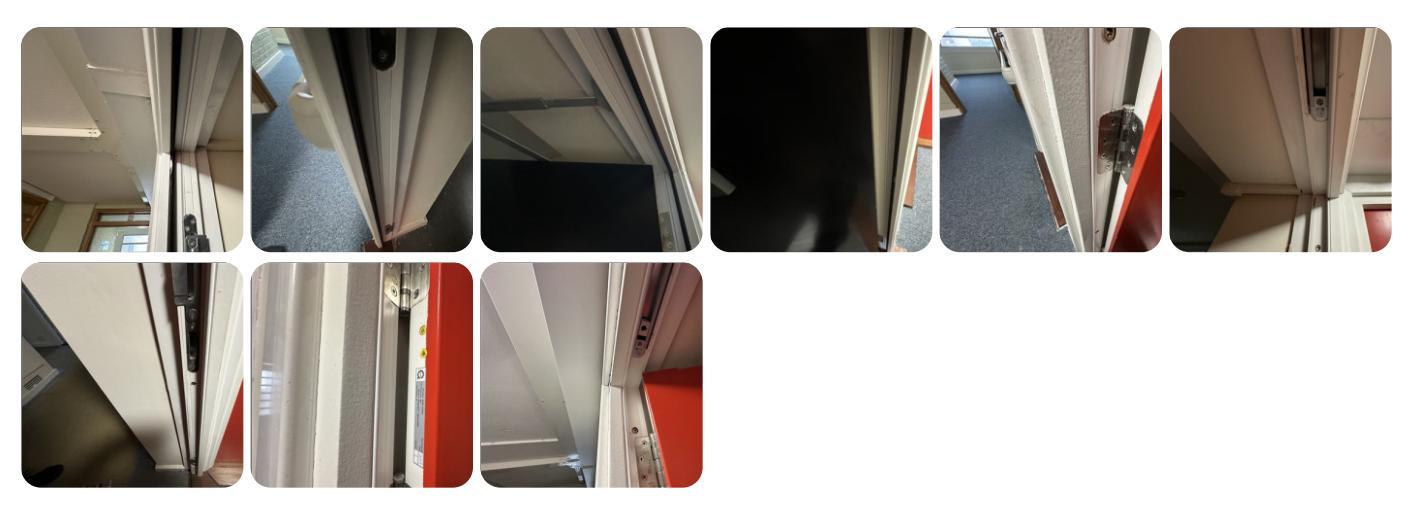
QUESTION 66 PHOTOS

All flats sampled were fitted with intumescent strips and cold smoke seals.

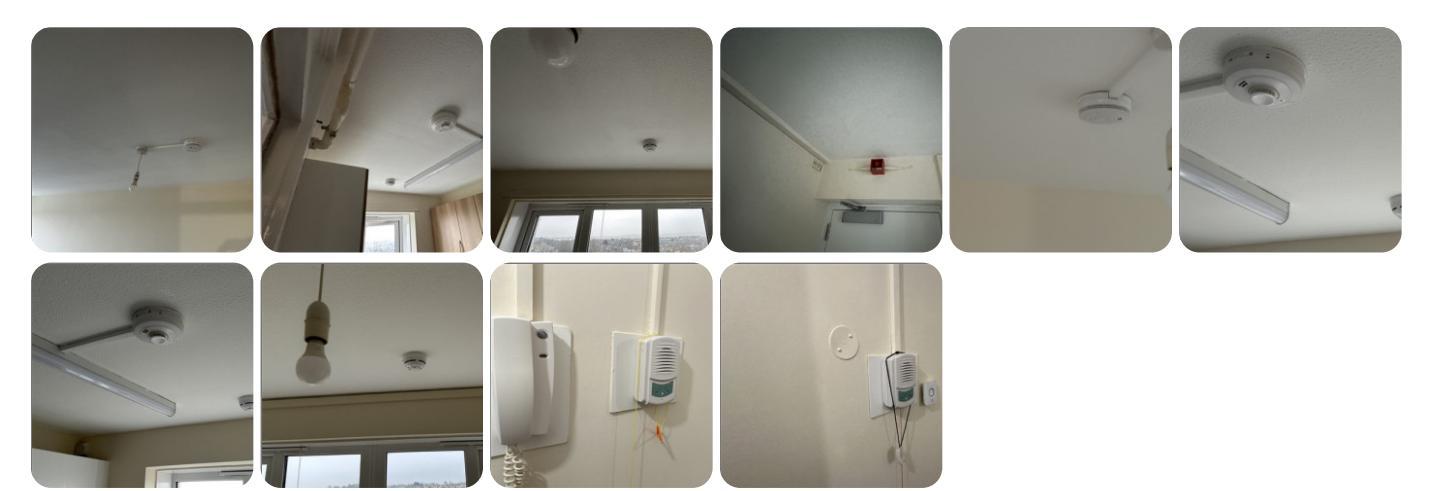
QUESTION 67 PHOTOS

Each flat is fitted with a Tunstall alarm.
