# Pyramid™ Risk Management System

## Fire Risk Assessment Review

### Flat 1-27, Elizabeth Court [UPRN:CCCBLK150590A] (General Needs)

**Type 4 Fire Risk Assessment**

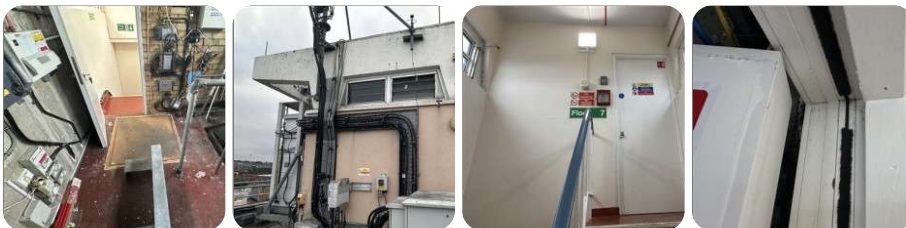
**QUESTION 60 PHOTOS**

The door to the lift motor room is missing a piece of cold smoke seal at the top of the frame on the hinge side. This may allow the spread of smoke.

CCC are to replace the missing cold smoke seal.

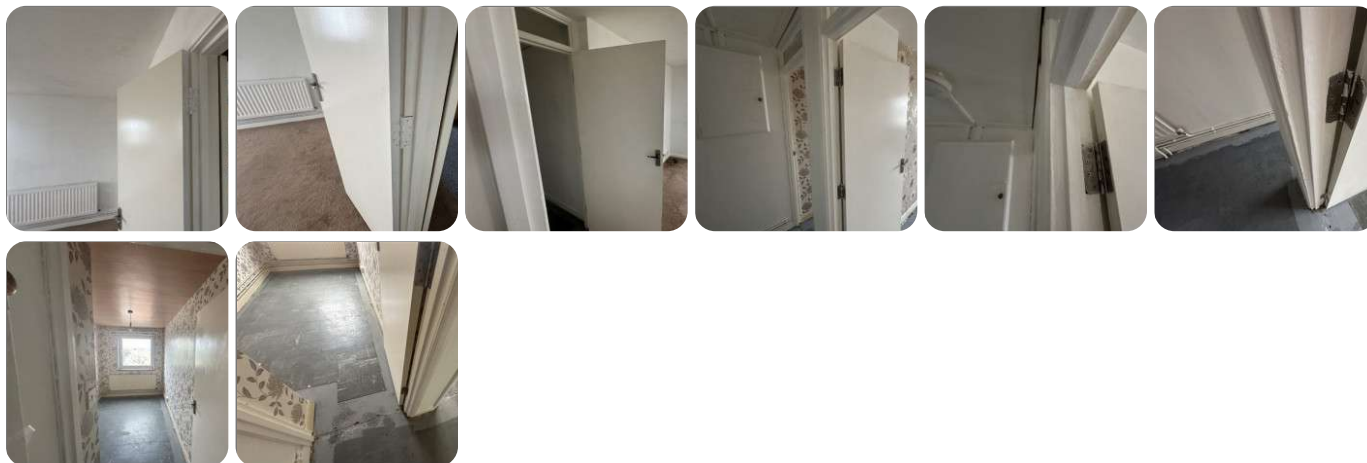
[QUESTION 69 PHOTOS](#)

**Question 69 (Section: Inspection ( Resident Flat))**RESIDENT FLAT : Where appropriate do internal hazard rooms appear to be of fire resisting construction (Based on external visual inspection)? **No****Risk Rating:**

CCC are to either fit intumescent strips to the doors or replace the doors with new FD30 fire doors.

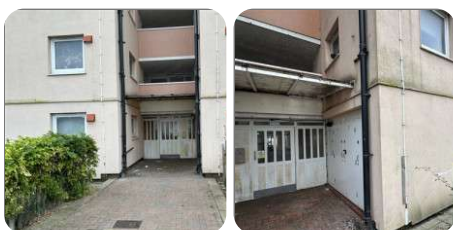
### QUESTION 1 PHOTOS

The outside of the building was noted to be clean and tidy, and free from build up of rubbish, other combustible materials, and hazardous waste, at the time of the assessment.

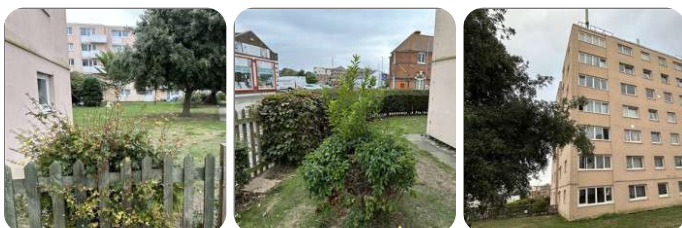
### QUESTION 2 PHOTOS

The outside of the building was noted to be clean and tidy and free from build up of vegetation.

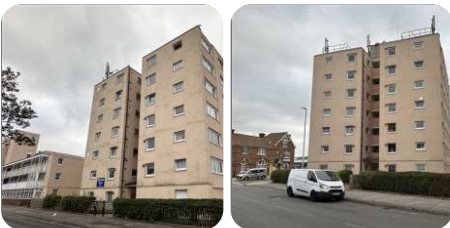
#### [QUESTION 15 PHOTOS](#)

No issues found at the time of the inspection plenty of room for FRS to the front and rear of the building.

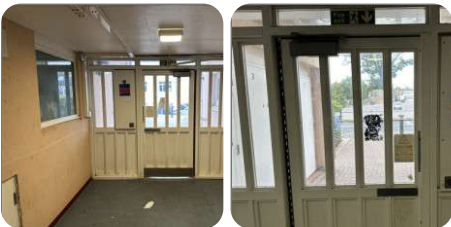
QUESTION 26 PHOTOS

**Assessors Note**  
CCC have decided not to fit over rides to the doors as they are connected to the fire alarm system and fail safe, there are two doors so one will always operate and that they are worried that the over rides will be abused / damaged by residents.

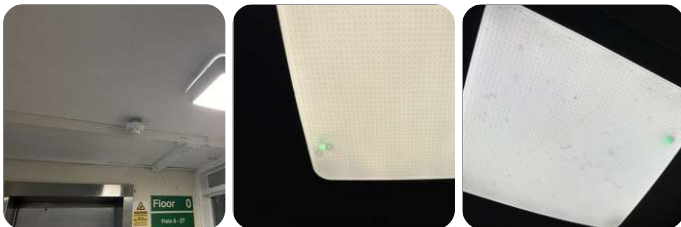
## QUESTION 49 PHOTOS

No issues found at the time of the inspection. Emergency lights are provided within the communal areas.

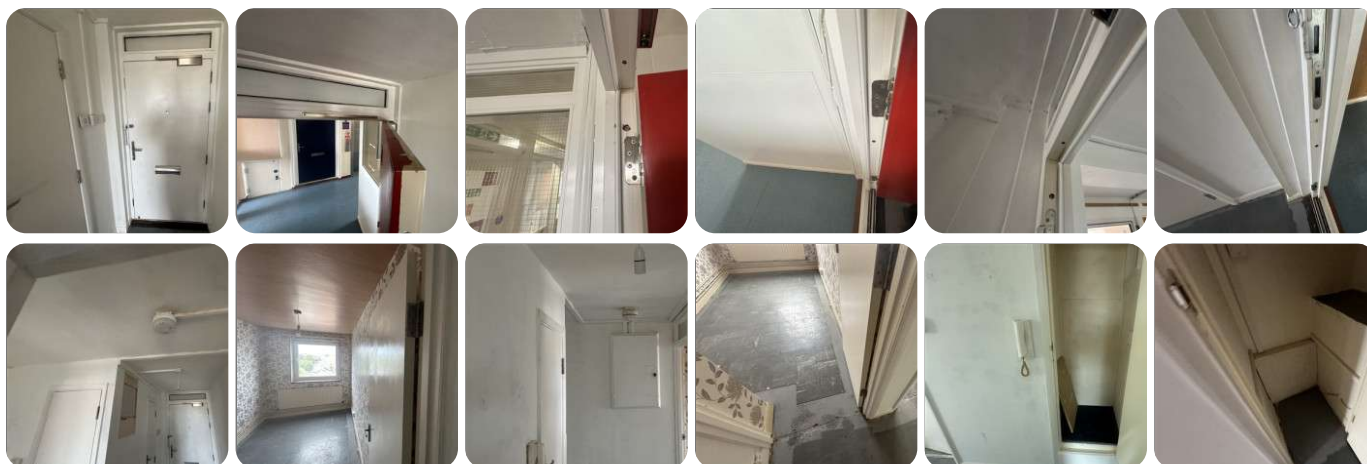
## QUESTION 75 PHOTOS

The compartment floors and ceilings within flat 21 are of a solid masonry construction.
