Fire Risk Assessment Review

Margaret Court, Kings Road [UPRN:CCCBLK150450A] (Semi-Independent Living)

Type 1 Fire Risk Assessment

DDS Job Number: 65496

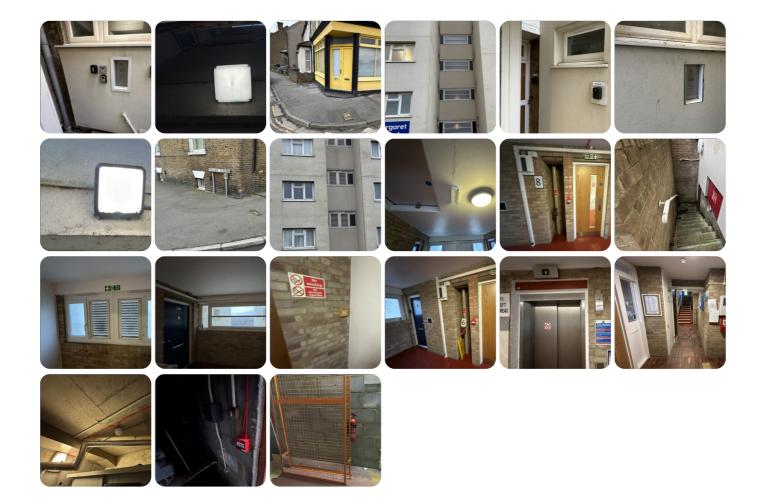
Section 2.2 - Fire Protection		
Fire authority: Kent	Fire and Rescue Service	
During the course of this risk assessment, th	e following history of previous fires was noted:	
No information provided at the time of the i	nspection.	
During the course of this risk assessment, th	e following history of previous false alarms was noted:	
No information provided at the time of the i	nspection.	
Communal area automatic fire alarm systen present:	n Yes; Addressable system	
Communal area fire alarm system:	Hard Wired (into Fire Panel) Detection, Manual Call points, Sounders present, Visual aid devices (beacons)	Commissioning No certificate:
Further details of communal area fire alarm	system:	
	dial works following the Cause and Effect and External Wall survey's the detection ystem with detection in all areas / rooms. However at the time of the assessment r	
Communal area fire alarm system Categ category:	ory L1 : system installed throughout all areas of the building

Pictorial Zone Plan displayed Yes adjacent to the fire panel:		
Further details of automatic fire alarm syste	m:	
Fire alarm panel located on ground floor in l	ift lobby.	
Further details of communal area fire alarm	system Pictorial Zone Plan:	
This is displayed on the wall to the left of the	e fire alarm panel on the ground floor.	
Resident accommodation fire detection & sounders:	Mains Wired Domestic Detection Commissioning certification	ite: No
Resident accommodation system category:	Category LD2 : a system incorporating detectors in all circulation areas that for routes from the premises, and in all specified rooms or areas that present a high including any kitchen and the principal habitable room	
Detection connected to the communal area system:	Νο	
Further details of resident accommodation	fire detection & sounders:	
The detection within flats 4, 29, 32 & 33 app inspected.	bears to be of a LD2 standard. With mains wired detection in the living room, hallw	ay and kitchen of each flat

Lightning protection present:	Yes	
Fire service drop key fitted?:	Νο	
Any other fire protection systems i place:	n No	
Passive Smoke Control Present:	Yes	
Further details of POVs:		
POV,'s located within staircase on	each floor.	
Active Smoke Control System Present:	Yes	
Further details of automatic smoke	control system:	
AOV's located on each floor within	the flat lobby.	
Any other fire engineered solutions:	Νο	
Emergency lighting present:	Mixed (Maintained and NonCommissioning certificate:NoMaintained)	
Further details of emergency lighti	ng:	
There is both maintained and non-	maintained emergency lighting installed internally and externally.	
Fire fighting facilities:	Dry Risers	
Fire extinguishers:	CO2 Fire Extinguishers	
Sprinkler system coverage:	None	
Hydrant locations known:	Yes Distance - Nearest hydrant to building (approx):	21m - 30m
Further details of hydrant locations	5:	
Hydrant located on the corner of V	/illiam Street / Kings Road junction and outside 2 Gordon Road on the pavement.

Security provision:	Yes Security provision types: Access Control Systems	
Further details of Security Provisio	n:	
Intercom systems fitted to both the	e front and rear entrance doors.	
Secure Information Box present:	Yes Key safe present:	Yes
Further details of Secure Informati	on Box:	
Located by fire alarm panel.		
Further details of key safe:		
Located at rear entrance - Code 40	286.

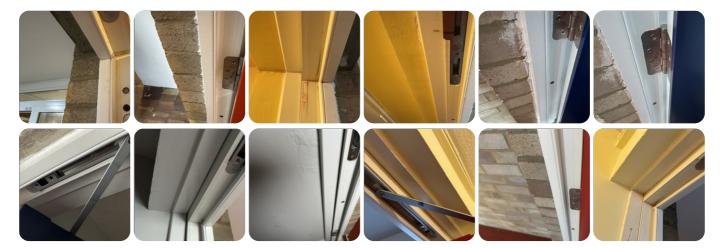
QUESTION 66 PHOTOS

All flat front doors were fitted with intumescent strips and cold smoke seals.
