Proposed Residential Development  
Land South of The Hill, Littlebourne

Proposed Puffin Crossing

Stage 1 Road Safety Audit

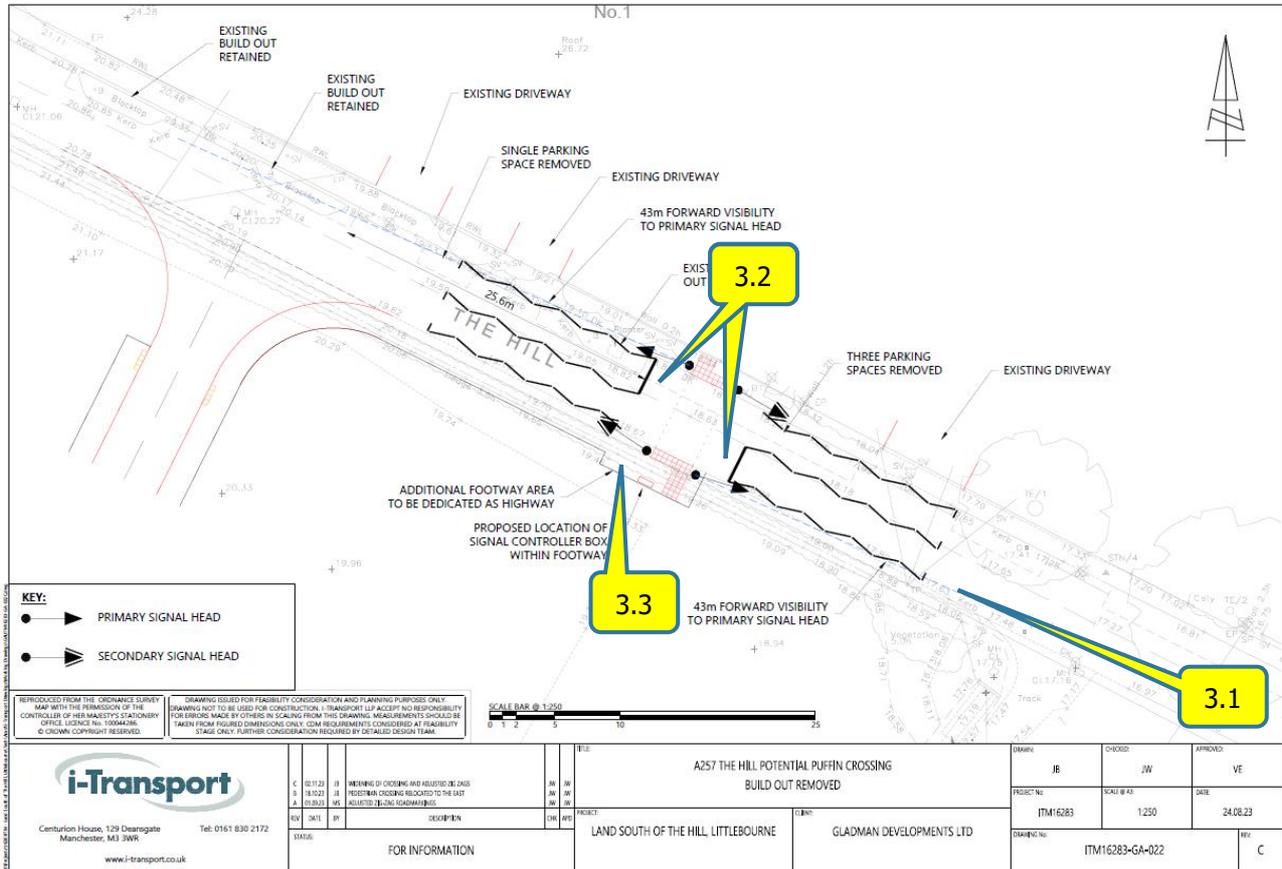
## 6. LOCATION PLAN OF ITEMS RAISED BY THIS AUDIT

Given the straight alignment of The Hill, forward visibility of the crossing (and hence the stopping sight distance) should be achievable. However, there is heavy shrubbery on the south side of the road, and the measured average 85<sup>th</sup>ile westbound speed is just under 35mph. Providing sufficient visibility will reduce the risk of overshoots or sudden braking at the crossing.

The distances between the pedestrian crossing studs and the vehicle stop lines are not specified on the drawings at this stage, and it is possible that they could be laid in close proximity during construction. Accidents can occur at signal controlled crossings because drivers of high fronted vehicles can pull away unaware of the presence of pedestrians, particularly those who are slow moving and who cross close to their vehicles. This problem can be mitigated by ensuring that adequate visibility of pedestrians is available to drivers and given effect by providing sufficient distance from the stop line to the crossing studs.

There is no provision for a maintenance vehicle to park close to the crossing (unless the additional footway area is intended as such). It is possible that the operative will park either fully on the

carriageway or partly on the footway, with the attendant risks of compromising visibility of the crossing and of obstructing through traffic.

It is recommended that the forward visibility of the crossing is specified as appropriate for the measured approach speeds, and that any potential obstructions are either relocated or removed.

It is recommended that the stop lines are specified as a minimum distance of 3m from the crossing studs (2.5m from the primary signal post) and shown as such on the drawings.

It is recommended that a hardstanding is provided close to the crossing (this could be adjacent to the controller on the additional footway area, which may need extended). If this recommendation is accepted and progressed, it is also recommended that a sign is erected close to the hardstanding to inform road users that the area is to be used by maintenance vehicles only and thus discourage indiscriminate parking.
