Margret Court – Fire Risk Appraisal of External Walls

Margret Court
Kings Road
Herne Bay
CT6 5XA

Buidtech Consultancy Ltd.

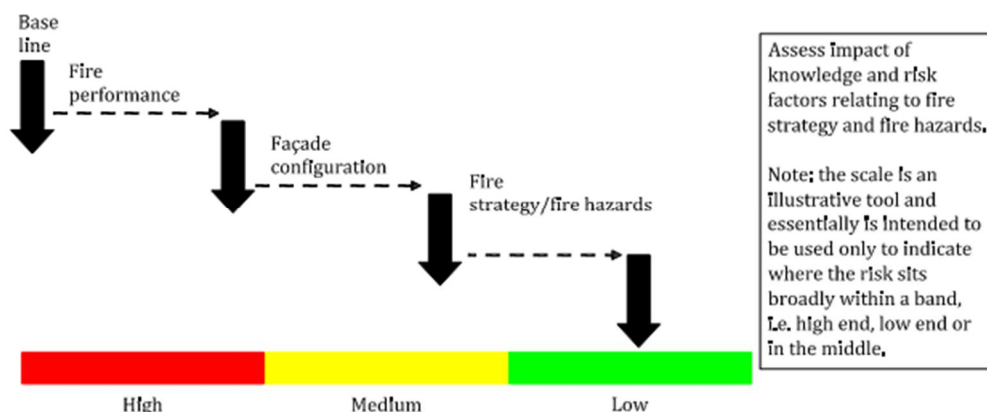
On completion of the evidence gathering portion of the FRAEW process all appropriate risk factors will be identified and collated into relevant groups. For each group, the likely influence of each of these factors needs to be considered when assessing their contribution in terms of achieving the success criteria. Each group will be concluded to have a positive, negative or neutral influence on the residual risk presented by the external wall system. Once each risk factor is identified and its influence weighted the results are applied to a High, Medium, Low scale, with the base line set as the highest risk and each group effecting the position of the risk along said scale. Please see below illustration as an example.
