Fire Risk Assessment Review

Flat 1-70, Windsor House, Belmont Road [UPRN:CCCBLK310130A] (Independent Living)

Type 3 Fire Risk Assessment

DDS Job Number: 72614

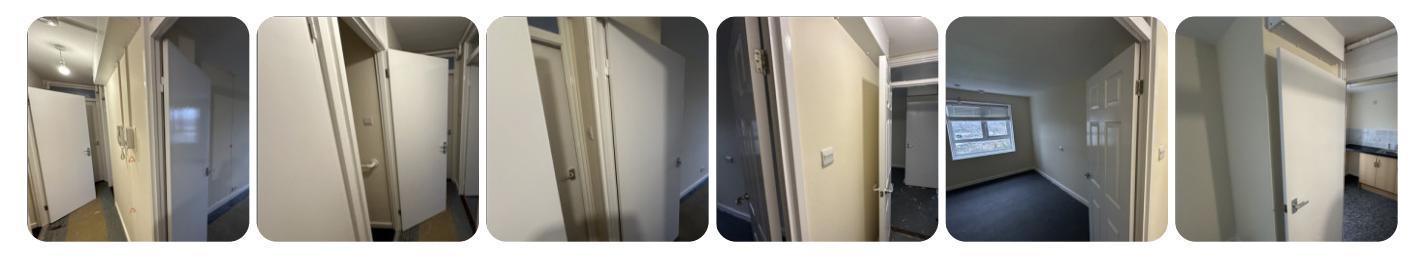
QUESTION 69 PHOTOS

RESIDENT FLAT : Where appropriate do internal hazard rooms appear to be of fire resisting construction (Based on external visual inspection)? **No**

1. The hazard room doors and bedroom doors within the flats inspected have only two hinges and no intumescent strips and cold smoke seals fitted.

1. CCC are to either upgrade all the internal doors with 3 fire rated hinges, intumescent strips and cold smoke seals or replace them with new FD30s fire door sets.

2. CCC are to either replace the glass panels with fire rated glass or remove and replace with a sheet of fire board.

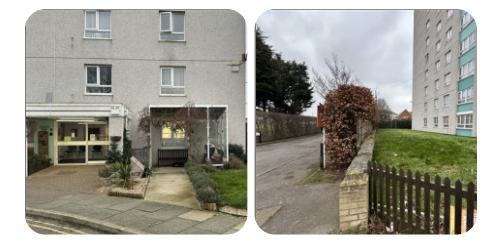
QUESTION 2 PHOTOS

The outside of the building was noted to be clean and tidy and free from build up of vegetation.

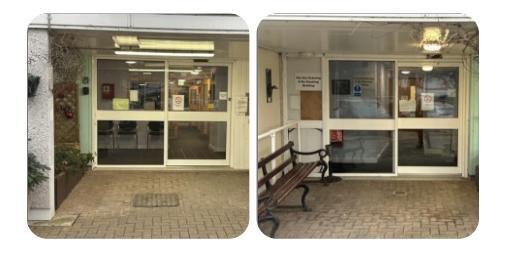
QUESTION 12 PHOTOS

No discarded smoking materials seen at the time of the inspection.

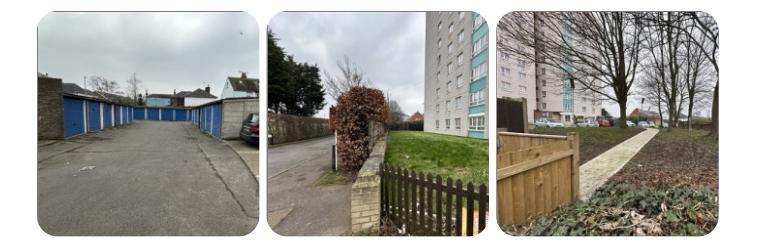
No BBQ's or bonfires seen at the time of the inspection.

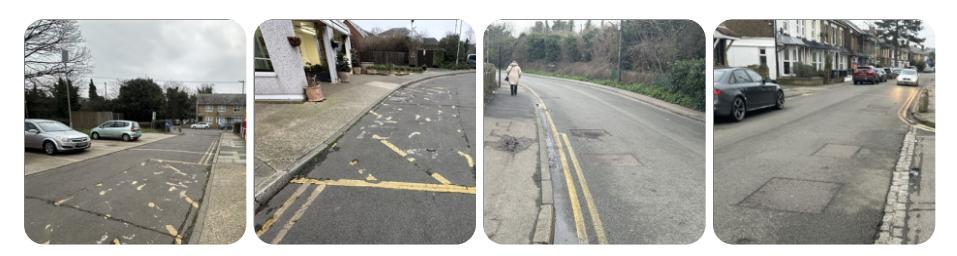
QUESTION 15 PHOTOS

The FRS can approach along Belmont Road and park to the front of Windsor House in the dedicated marked hatched area.

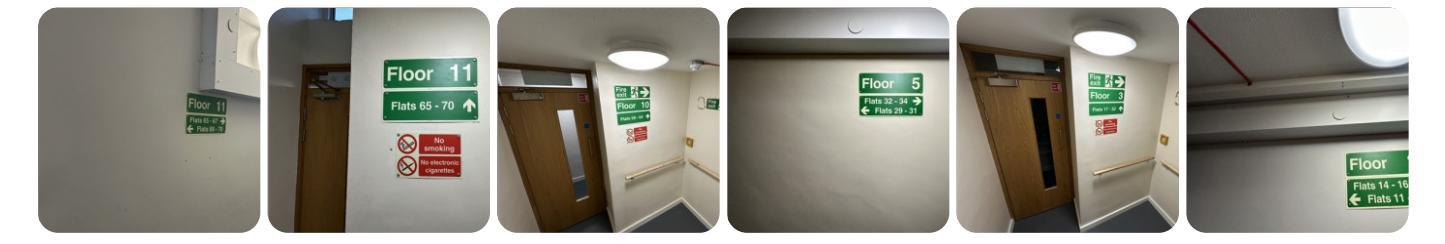
QUESTION 21 PHOTOS

Wayfinding signage was present throughout the building at each level and directs which way flats are and the level of the building you are on.

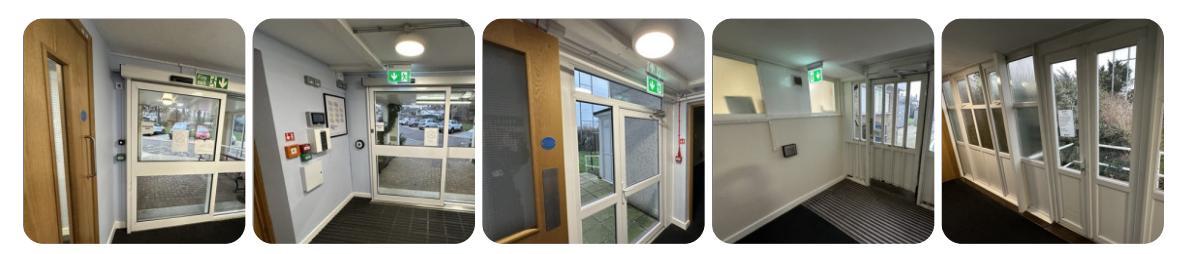
QUESTION 22 PHOTOS

All other doors to external areas are thumb turn/push handle operation. None were found to be open at the time of inspection.

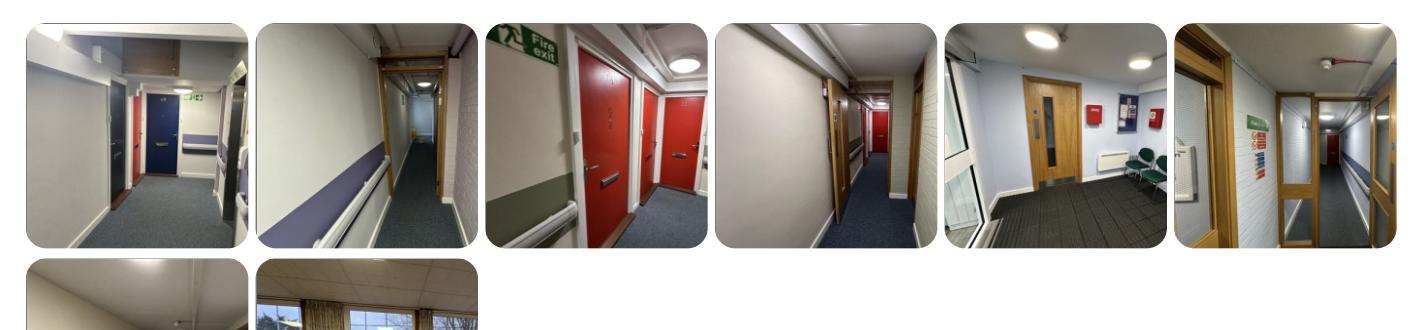
QUESTION 23 PHOTOS

Canterbury City Council operate a Managed Use Policy in the communal areas.

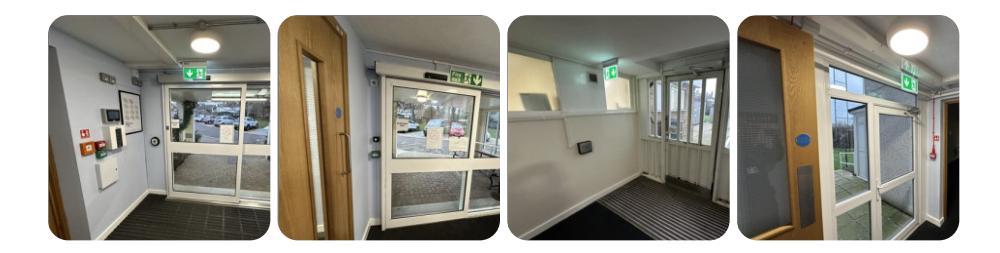
QUESTION 26 PHOTOS

No issues found at the time of the inspection, all exit doors found to open easily. Front entrance doors had over ride boxes fitted.

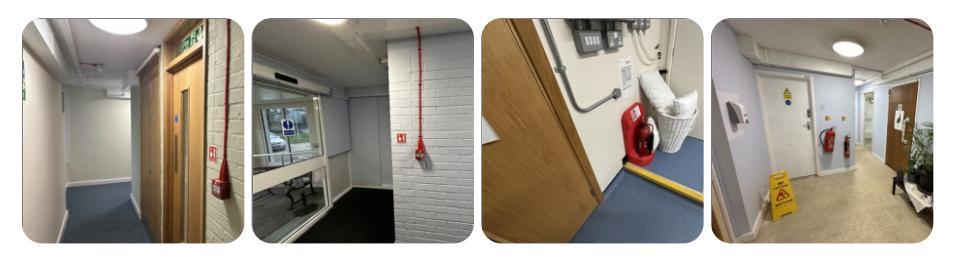
QUESTION 27 PHOTOS

No issues identified at the time of inspection. All extinguishers and manual call points were accessible.

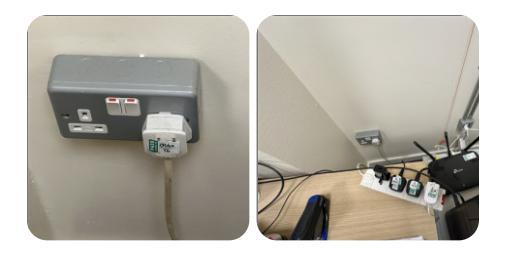
QUESTION 29 PHOTOS

No issues found at the time of the inspection electrical sockets were used correctly and not overloaded.

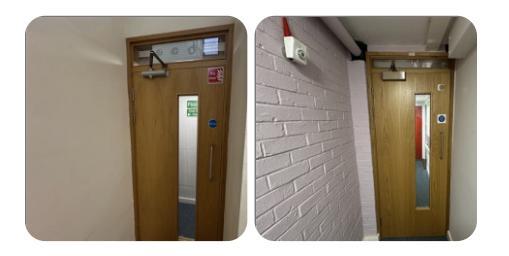
QUESTION 34 PHOTOS

All internal fire doors checked and were found to be free from obstructions.

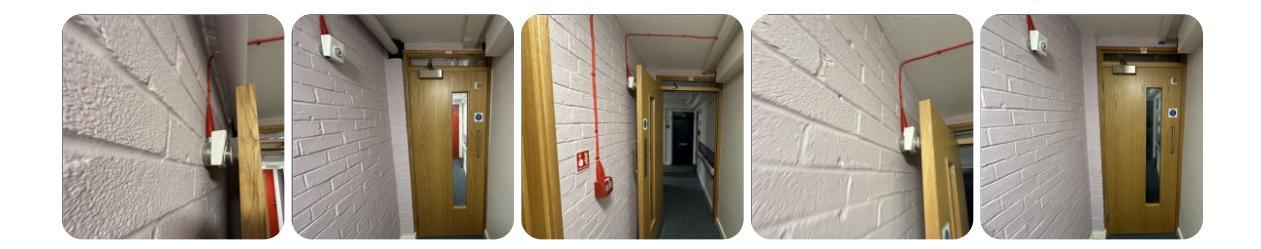
QUESTION 35 PHOTOS

All internal fire doors closed to completion and automatic release systems functioned correctly.

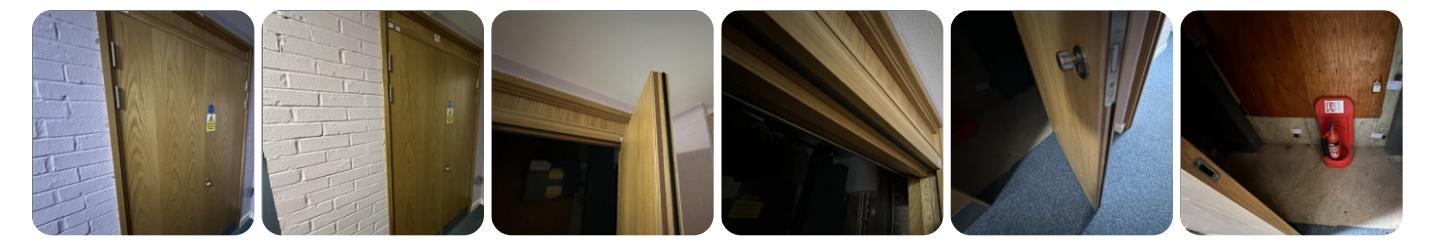
QUESTION 36 PHOTOS

At the time of inspection, the internal service cupboard was locked with a Canterbury City Council provided key. The door appears to be of a fire resistant construction.

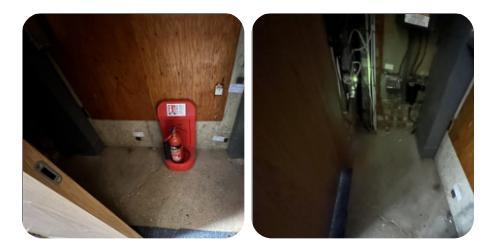
QUESTION 37 PHOTOS

At the time of inspection, the internal service cupboard was free of storage.

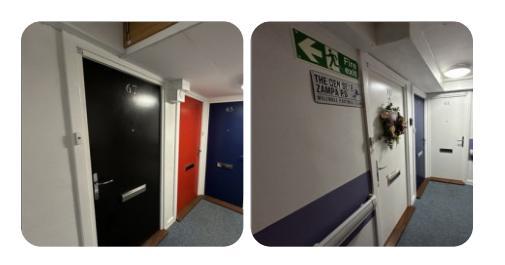
QUESTION 40 PHOTOS

All flat front doors were closed at the time of the inspection.

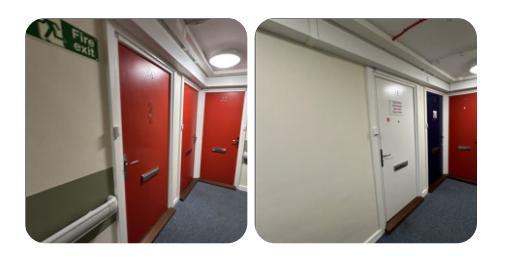
QUESTION 41 PHOTOS

The flat front doors appeared to be of a fire resisting construction.

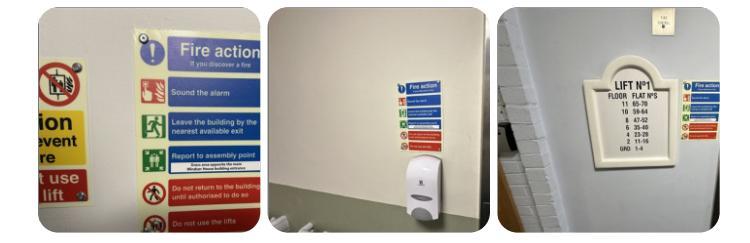
QUESTION 44 PHOTOS

No issues identified at the time of inspection. Correct Simultaneous Evacuation Fire Action Notice displayed.

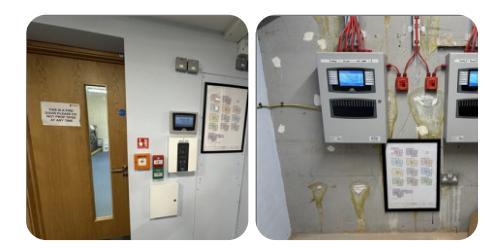
QUESTION 45 PHOTOS

The zone maps are displayed by the repeater panel and the main fire alarm panels.

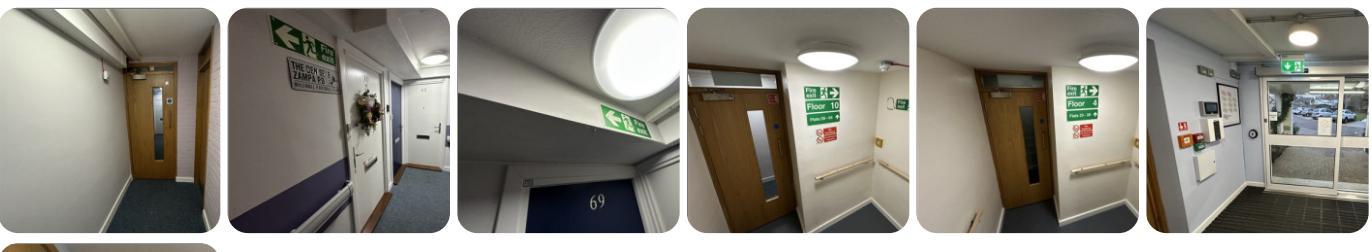
QUESTION 46 PHOTOS

No issues identified during the inspection, escape routes are clearly and correctly signed internally throughout the premises.

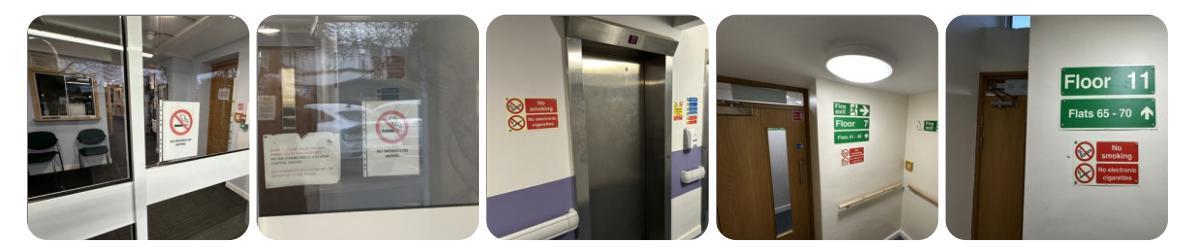
No Smoking signage was correctly displayed in the communal area of the building.
QUESTION 47 PHOTOS

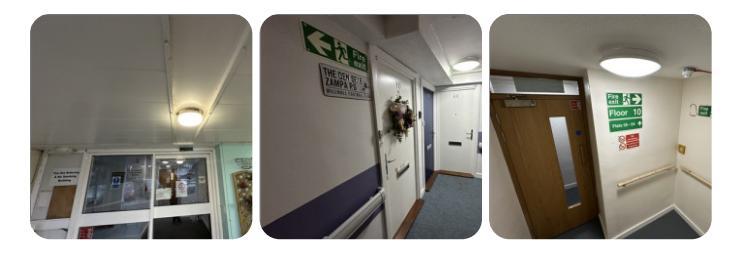
QUESTION 49 PHOTOS

No issues found at the time of the inspection. Emergency lights are provided within the internal communal areas.

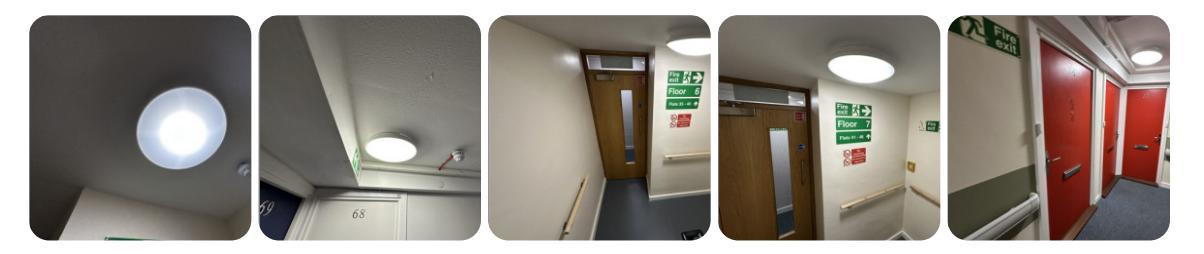
QUESTION 50 PHOTOS

Emergency lighting appears to provide adequate coverage of the communal areas. Emergency lights are displaying LEDs to indicate charging of the units.

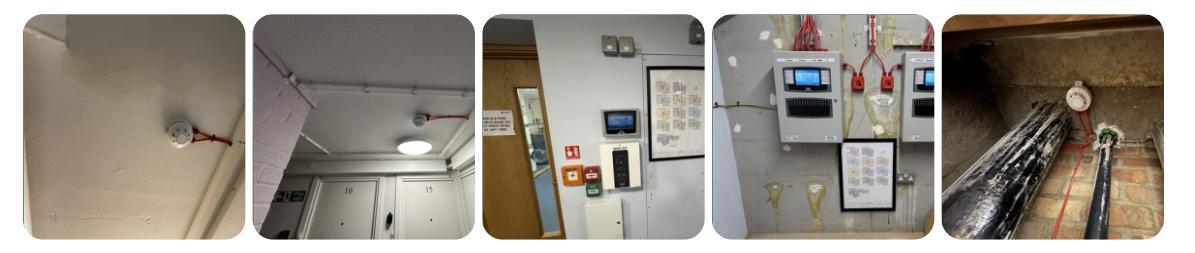
QUESTION 52 PHOTOS

The automatic detection present has been installed to the correct standard for the occupancy and risk. The automatic fire detection appeared to be free from faults with no issues displayed on the main panel.

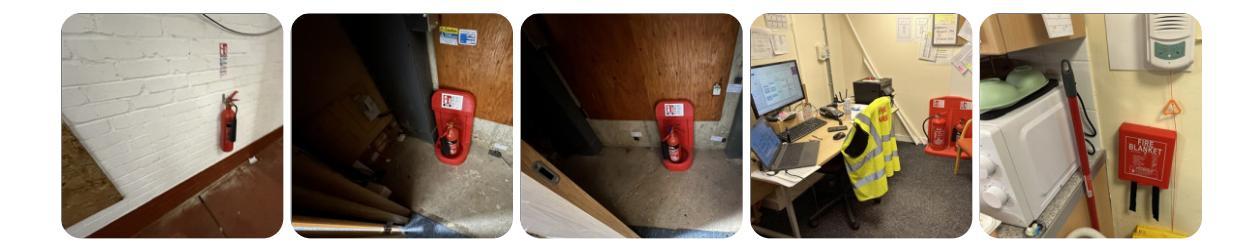
There are appropriate fire extinguishers provided in the higher risk rooms.

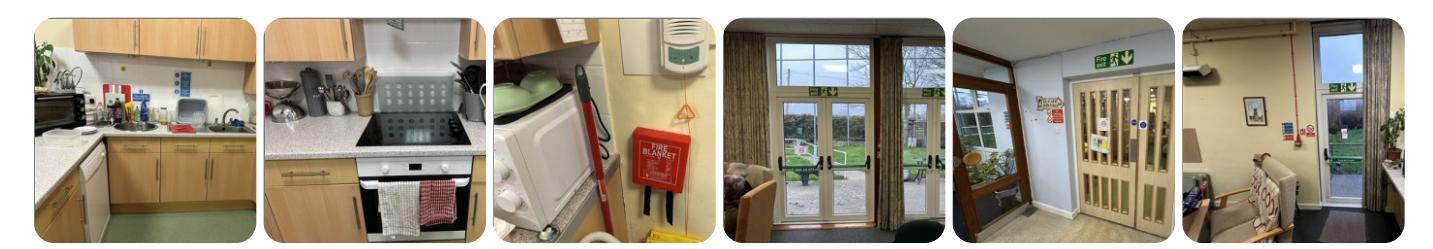
QUESTION 55 PHOTOS

There are a number of exits from the area which will allow safe egress from the lounge / kitchen area.

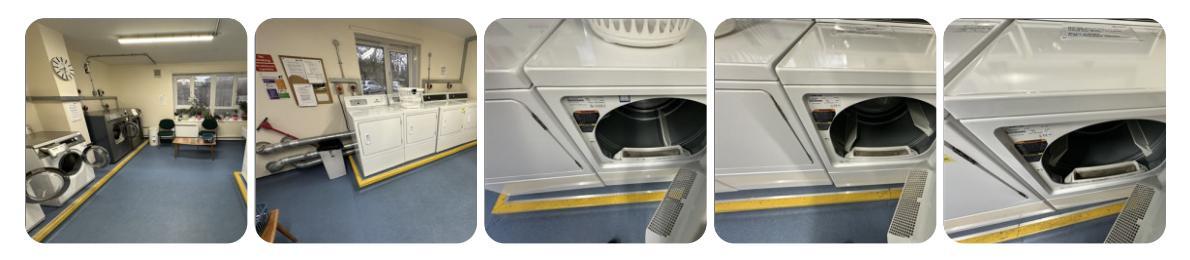
QUESTION 56 PHOTOS

The tumble dryers were free of lint.

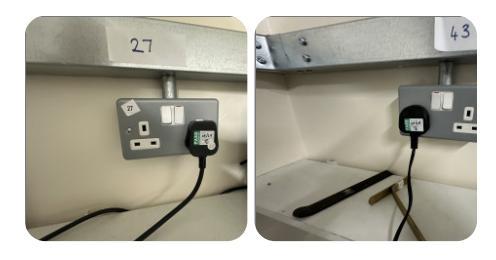
QUESTION 57 PHOTOS

The mobility scooter chargers were last PAT tested on 09/2024.

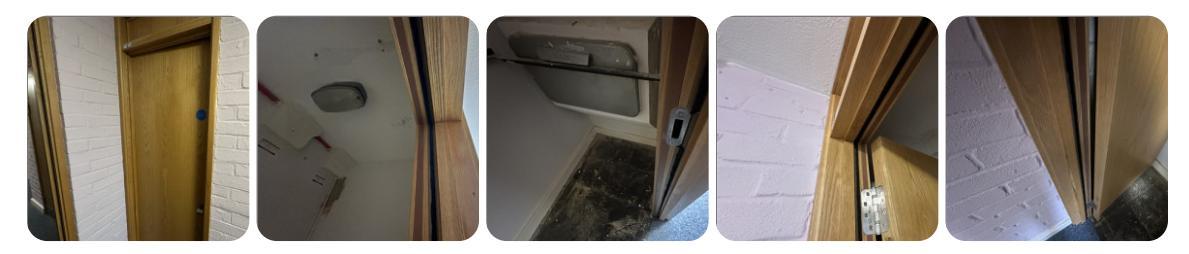
QUESTION 58 PHOTOS

The waste chutes have been decommissioned, so the doors are kept locked. The doors are of a fire resistant construction.

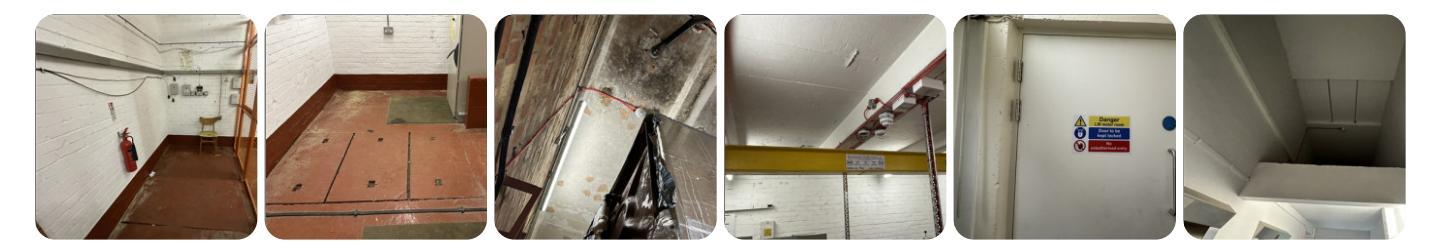
QUESTION 60 PHOTOS

The lift motor room is of a fire resistant construction and the trap door is constructed of concrete slabs.

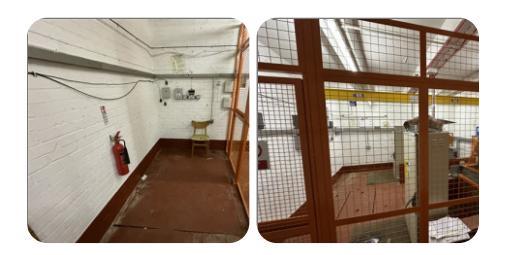
QUESTION 61 PHOTOS

The lift motor room was free from storage and combustible materials.

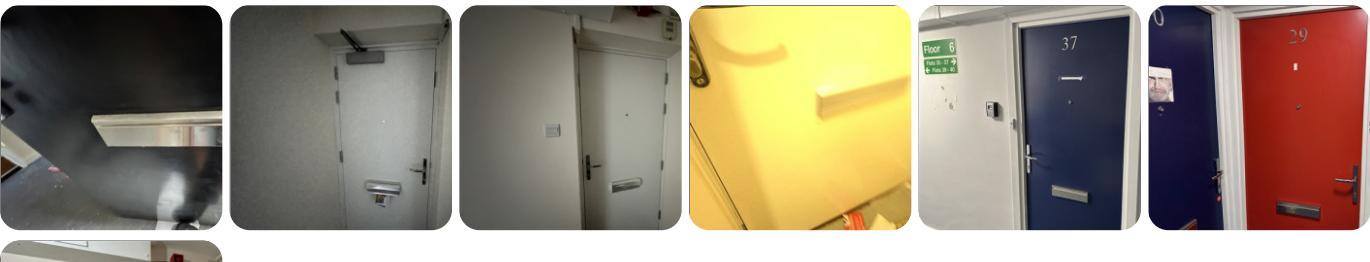
QUESTION 64 PHOTOS

All flats were fitted with fire rated letterboxes.

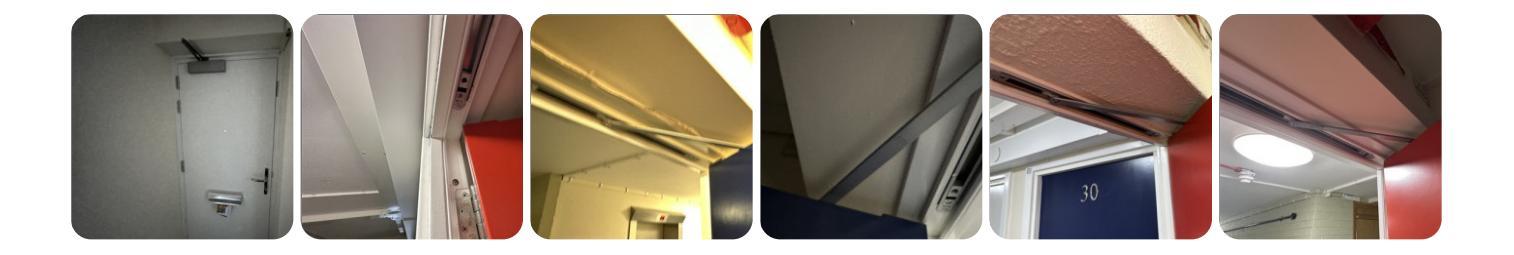
QUESTION 65 PHOTOS

Flat front doors are fitted with self closers and close to completion.

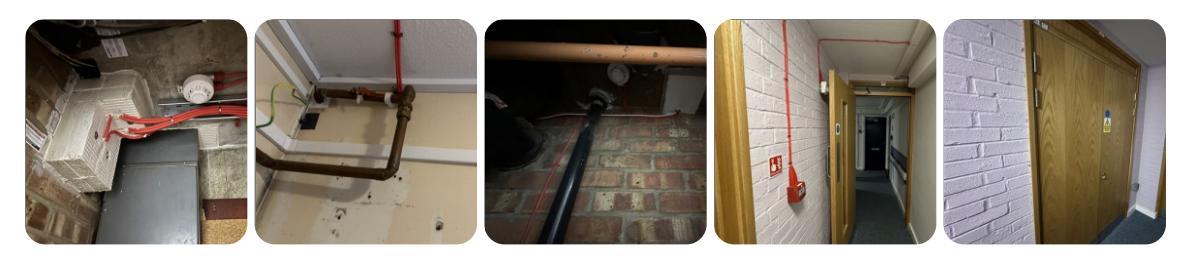
QUESTION 72 PHOTOS

No issues identified at time of the assessment. Compartmentation appeared to be of good standard within the building.

NO ACTION REQUIRED

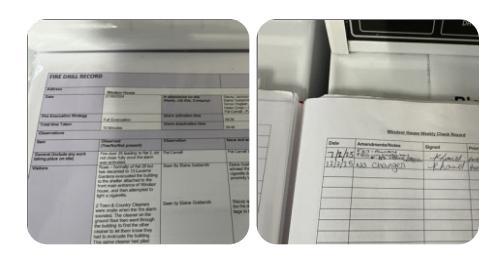
QUESTION 77 PHOTOS

Last fire drill dated: 27/09/202.

NO ACTION REQUIRED
